Effects of newly built hydrotechnical infrastructure on the Danube in Serbia

River Training and Dredging Works on Selected Sectors along the Danube River

**Preparation of Documentation for River
Training and Dredging Works on Selected
Sectors along the Danube River**

6th Stakeholder's Forum Meeting
Wed, 27. September 2023. (08:30-13:00 CEST)

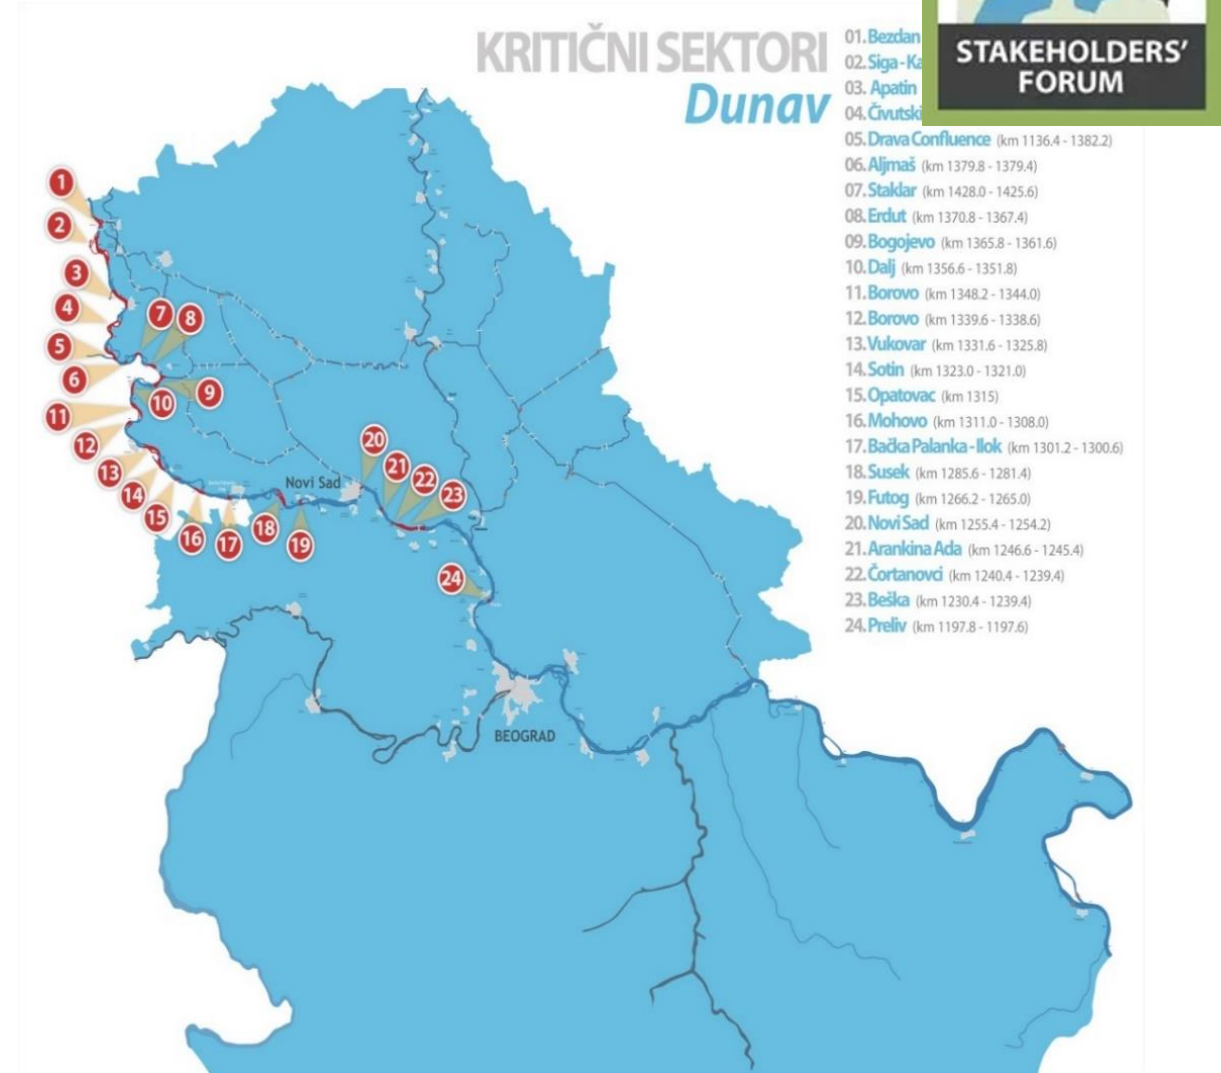
A total of 24 critical sectors have been identified in the Project area having limitations to navigation.

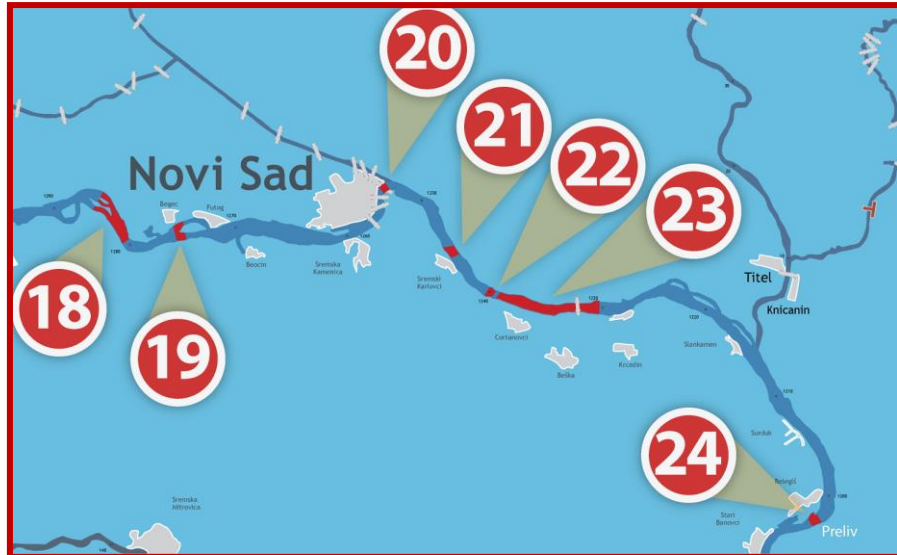
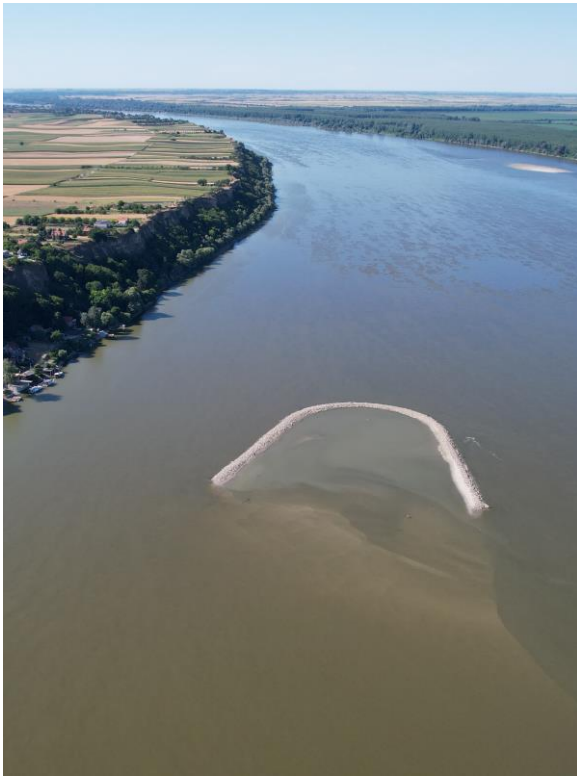
Chevrons - newly built hydrotechnical structures on the Danube River in Serbia

- Within the Phase 3 the Main Projects and Tender documentation for 6 critical sectors located downstream of Bačka Palanka were completed
- Hydrotechnical structures have been built in three of the six critical navigation sectors to improve navigation conditions
- Chevrons were built on two critical sectors (Futog and Preliv) - the first hydrotechnical structures of this type on the Danube
- All hydrotechnical structures were built in accordance with the "Handbook of Good Practice in Sustainable Waterway Planning"

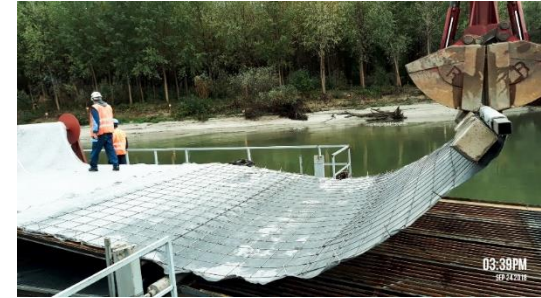
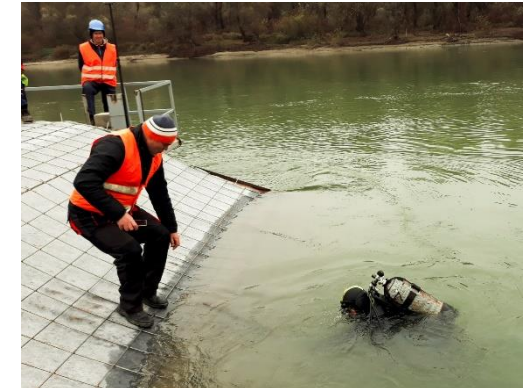
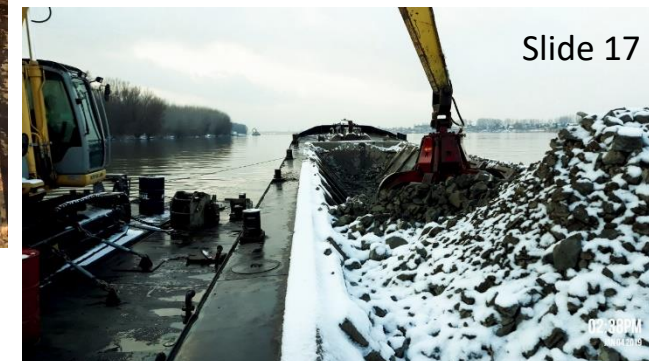
- Start of Works: August, 2018.
- Detached groyne is built at right bank (km 1263+350)
- Chevron is built at right bank (km 1262+800 – km 1262+700)
- All River Training Works on critical sector Futog have been completed on May, 2019.

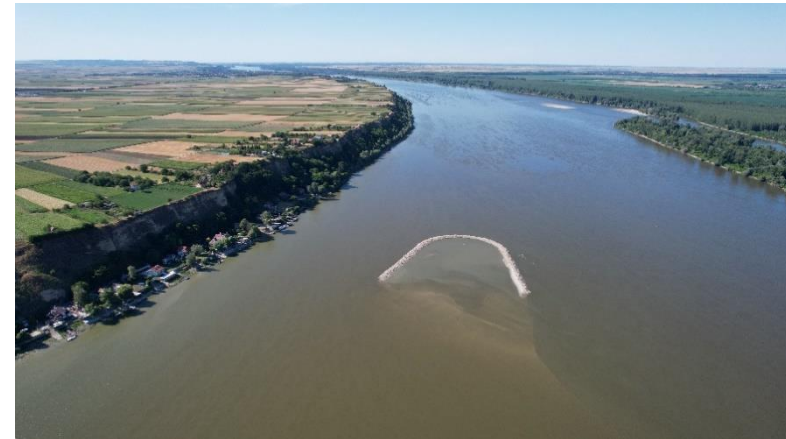
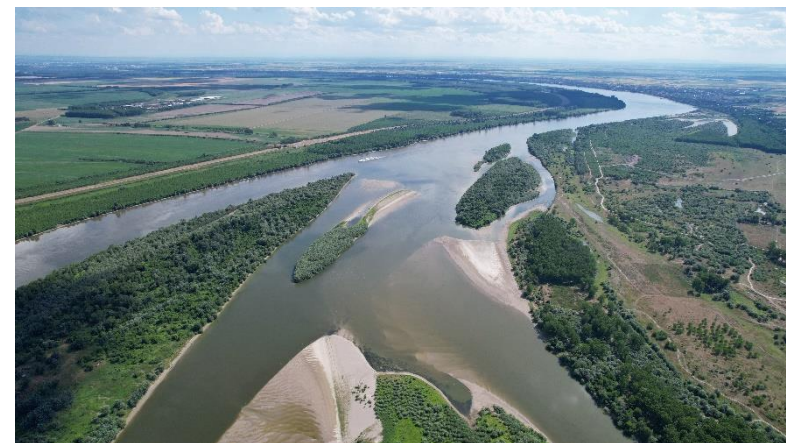
- The river widens at the sector Preliv.
- An island with unprotected banks diverts the flow into the main channel and a side channel.
- The main channel is located along the left bank and the side channel is located along the right bank.
- The side channel is wider and shallower than the main channel.
- **Due to the presence relocation of the main river axis from one bank to the other, vessels have experienced major navigation limitations in the past.**

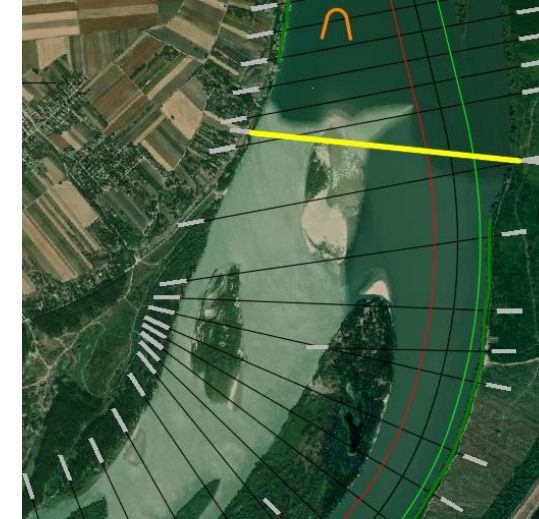
Profil Id: 242 km 1199.86 En = 70.43 m.n.m.

The river bed upstream of the side channel is highly morphological dynamic and the side channel was dominant in the past over the left - main channel.

Morphological changes of main and side channel
from 1994. to 2023. (cross section km 1199+860)
