Monitoring of hydrological, hydraulic and morphological characteristics of the Danube and inventory of biodiversity components of the Croatian-Serbian common section of the Danube

~Monitoring of parameters important for waterway maintenance~

31.01.2024. / Igor Tadić /Hidroing Ltd. Osijek; Slaven Marasović / VPB Ltd. Zagreb

Preparing FAIRway2 works in the Rhine Danube Corridor (2019-EU-TM-0262-S and 2019-HR-TMC-0263-S) The contents of this publication are the sole responsibility of the author and do not necessarily reflect the opinion of the European Union.

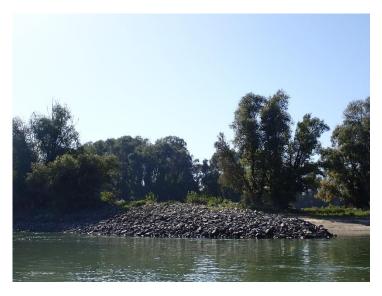
- Geometry data
- Geodetic survey
- Foto-documentation
- Assessment of the current state/functionality
- Identification of extent of damages (where applicable)

- Infrastructure in good condition
- Effect of material deposition ongoing (upstream, downstream)
- Material of the infrastructure visible, vegetation present on the beginning of the infrastructure

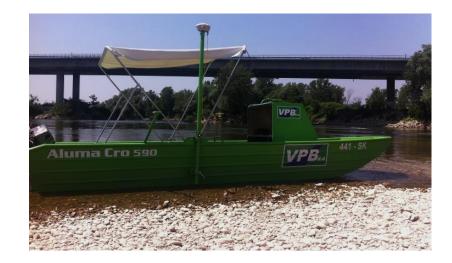
- Field work of hydrographic riverbed measurements of crosssections
- Overall length of ~ 140 rkm; 1375 (Danube)+6 (Drava) control profiles (equidistance of 100 m); 2 sets of measurements (yearly)

- First set of measurements conducted in 05-08/2023
- Data processing

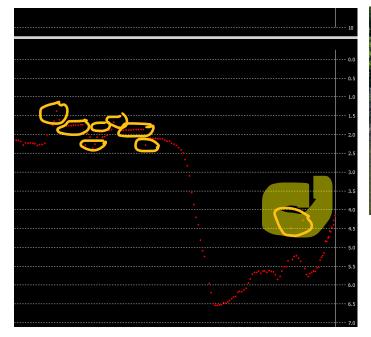
Projecting data on cross-section lines; surveyed daTa are projected on crosslines as a preparation for creating 3d model of riverbed.

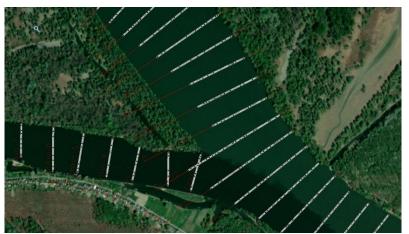
3D model; After cleaning and projecting, 3D model of terrain of riverbed was created.

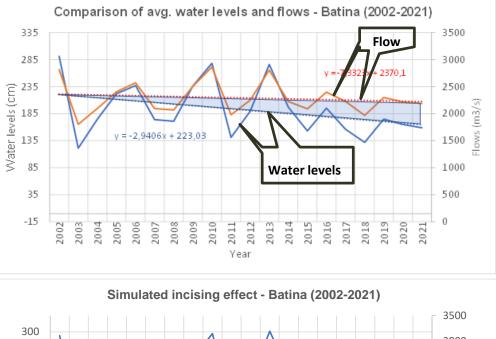
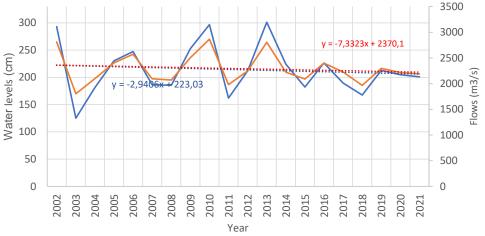
- Hydrological analysis undertaken prior to measurement campaign
- Comparison of water levels and flow data in analyzed timeline
 - Batina WM example
- General decline in values, sharper decline for water levels – incising effect
- Simulation of incising effect – 2,1 cm/ann for Batina WM station

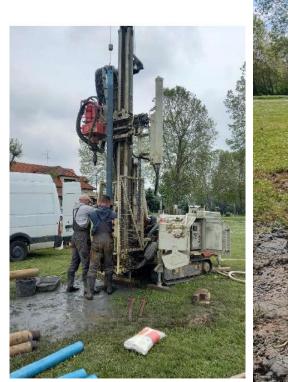
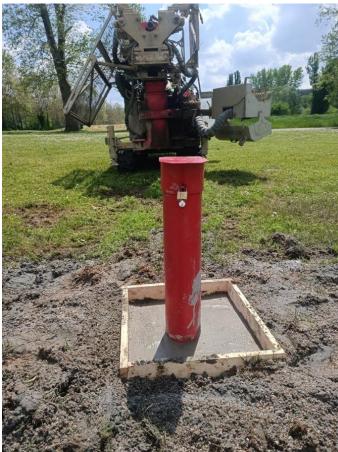
- Piezometer installation adjacent to Danube (<100 m), 15m of depth for continuous monitoring of water levels and temperature
- Locations: Batina, Aljmas and Ilok
- Goals: continuous data which shall enable correlation for any future hydrographic surveying and measurements

Installed piezometers, measurement equipment to be installed 01/2024
