# Monitoring of hydrological, hydraulic and morphological characteristics of the Danube and inventory of biodiversity components of the Croatian- Serbian common section of the Danube

~Monitoring of parameters important for  
waterway maintenance~

27.09.2023. / Igor Tadić /Hidroing Ltd. Osijek; Slaven Marasović / VPB Ltd. Zagreb

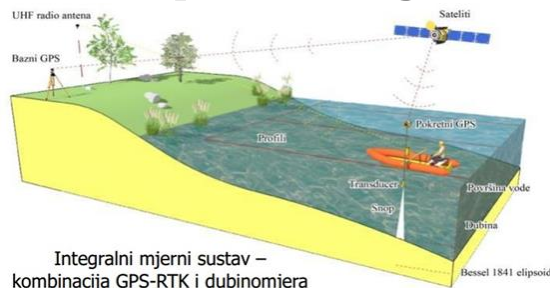
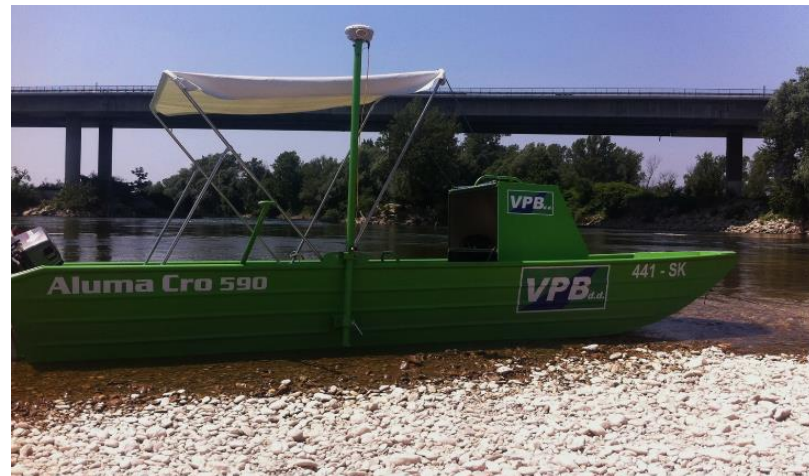
## ▶ *Riverbed measurement of cross-sections of Danube river*

- Field work of hydrographic riverbed measurements of cross-sections
- Overall length of ~ 140 rkm; 1374 control profiles (equidistance of 100 m); 2 sets of measurements (yearly)

- First set of measurements conducted in 05-07/2023
- Data processing

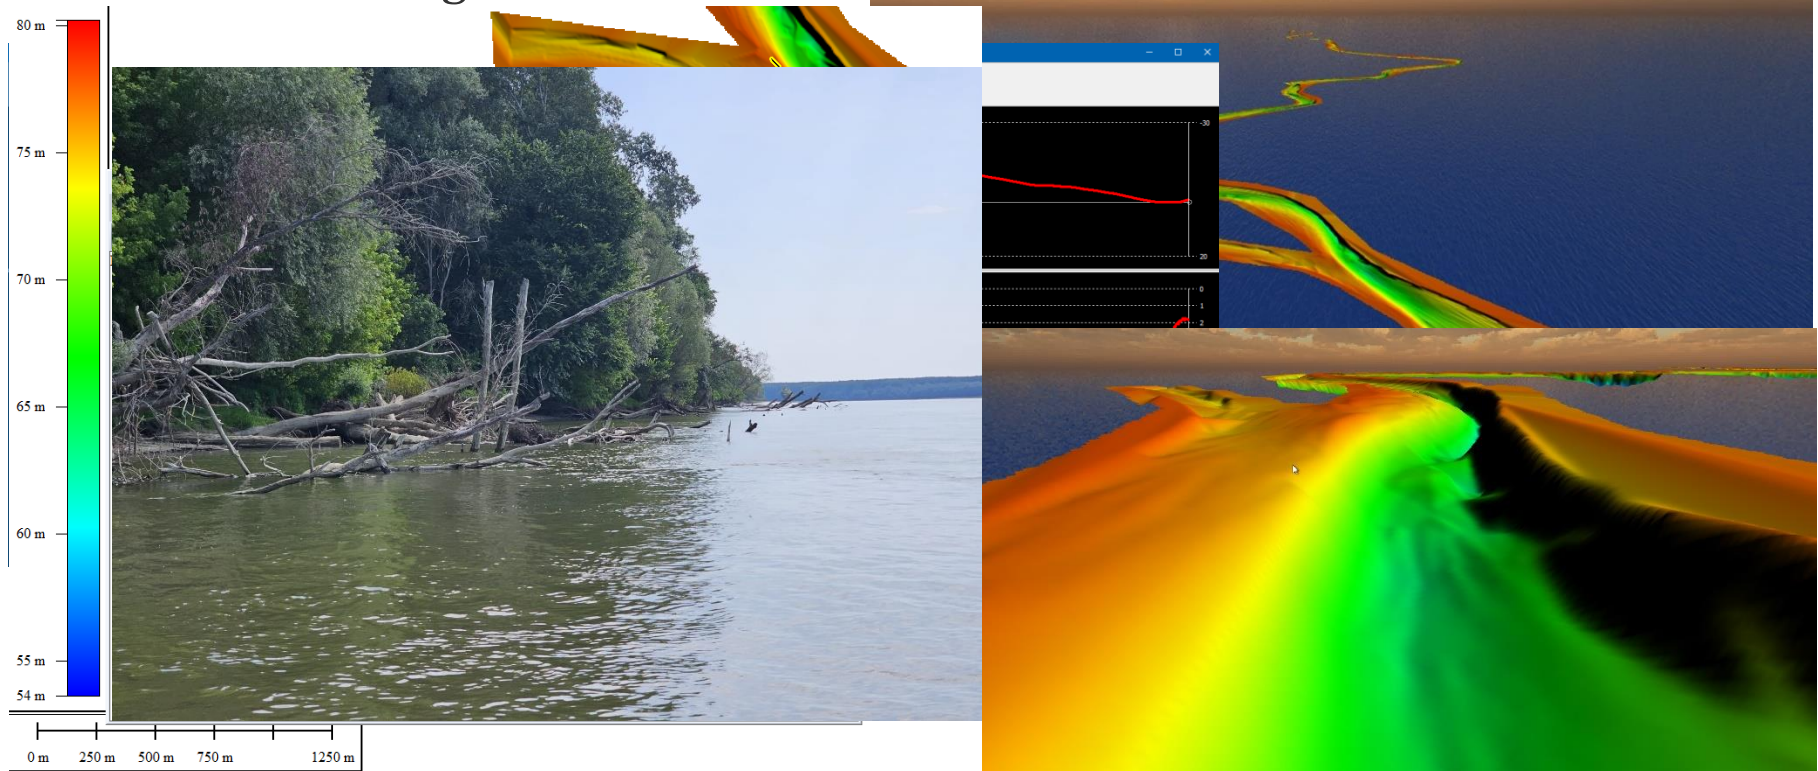
## ▶ *Cross-section data processing*

- Cleaning data
- Projecting data on cross-section lines
- Creating 3d model

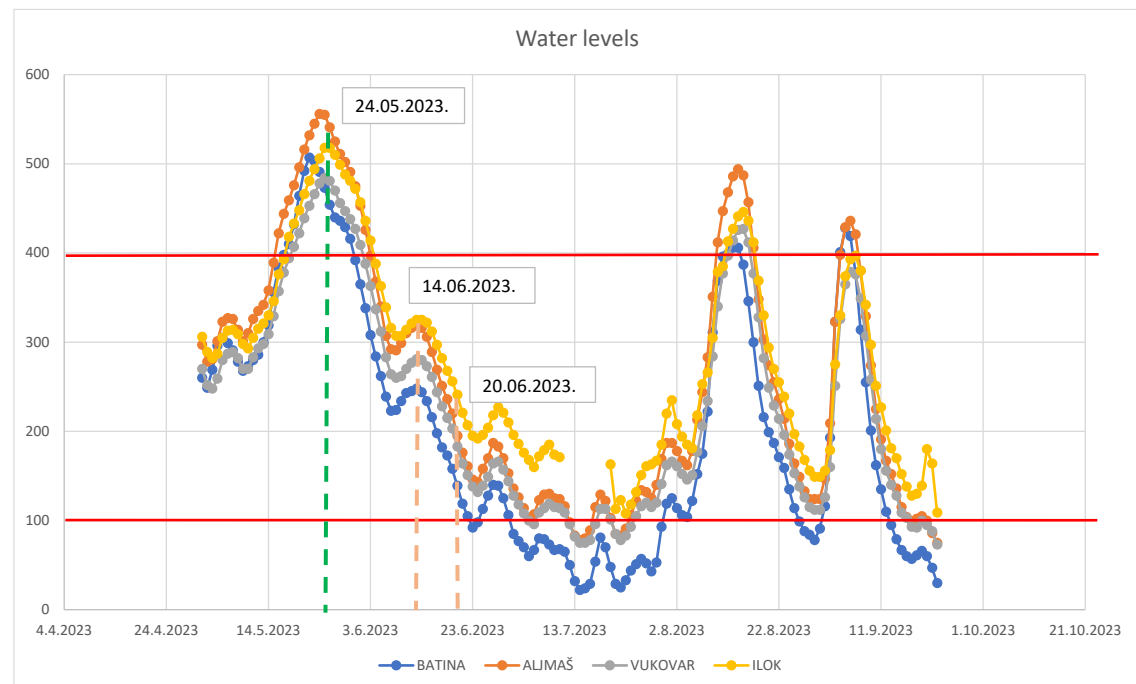
## ► Monitoring and analysis of flow, velocity and sediment transport

- 3 sets of measurement campaign (lower, medium and higher water levels) on 3 locations
- Locations: Batina/Vukovar/Ilok for flow and velocity measurements; Batina/Drava confluence/Ilok for sediment transport

- Measurement campaign for higher and medium water levels conducted
- Measurement campaign for lower WL in Q4 2023

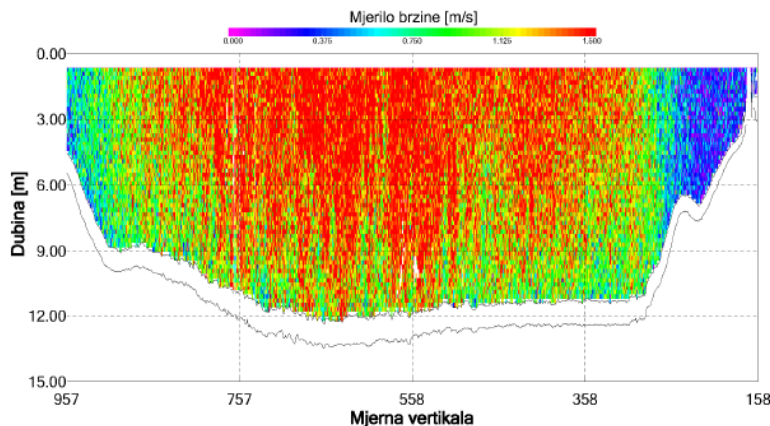
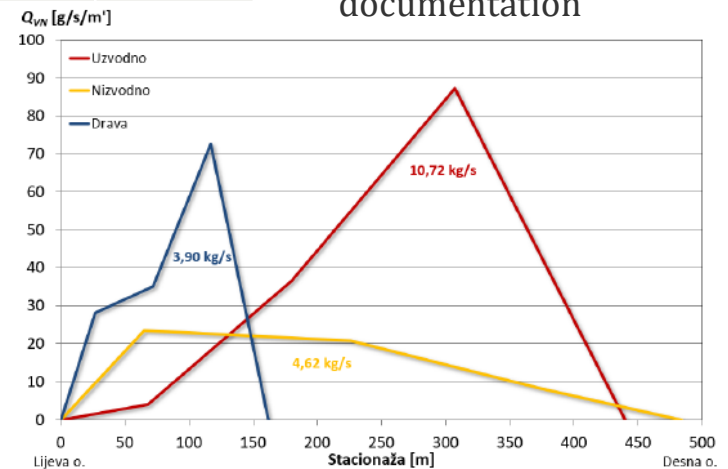
## ► Intermediate results (High water-level campaign) • Flow and velocity data distribution fairly consistent, bearing in mind cross section geometry (~ 1 m/s of integrated velocity, >1,5 m/s in main current)

- Bedload sediment 5-7% of total sediment
- Preliminary/intermediate results a product of direct method of analysis (measurement campaign), indirect method interpretation to ensue (correlation) within final documentation

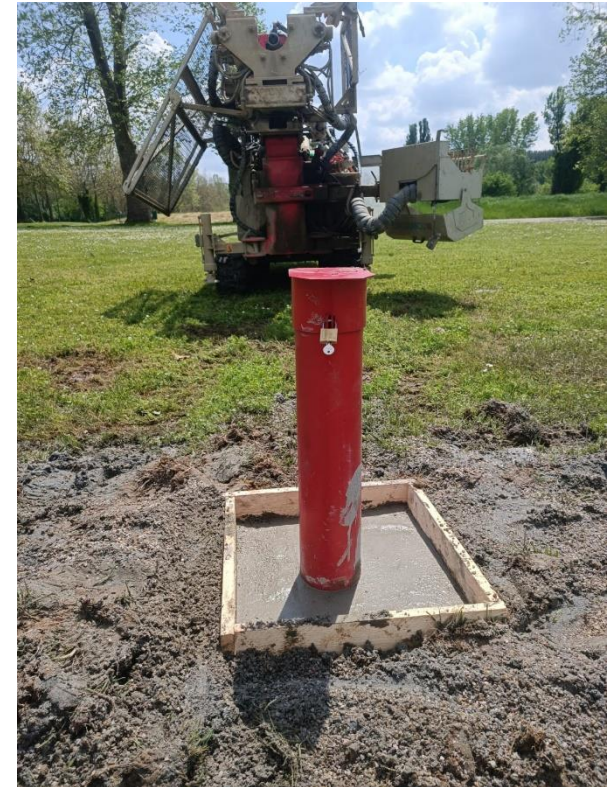
## *Piezometer installation*

- Piezometer installation adjacent to Danube (<100 m), 15m of depth for continuous monitoring of water levels and temperature
- Locations: Batina, Aljmas and Ilok

- Installed piezometers
